MoZEES Workshop

Hydrogen Safety: Kjørbo-incident, overview and perspectives

Olav Roald Hansen

CIENS, Oslo, October 23, 2019

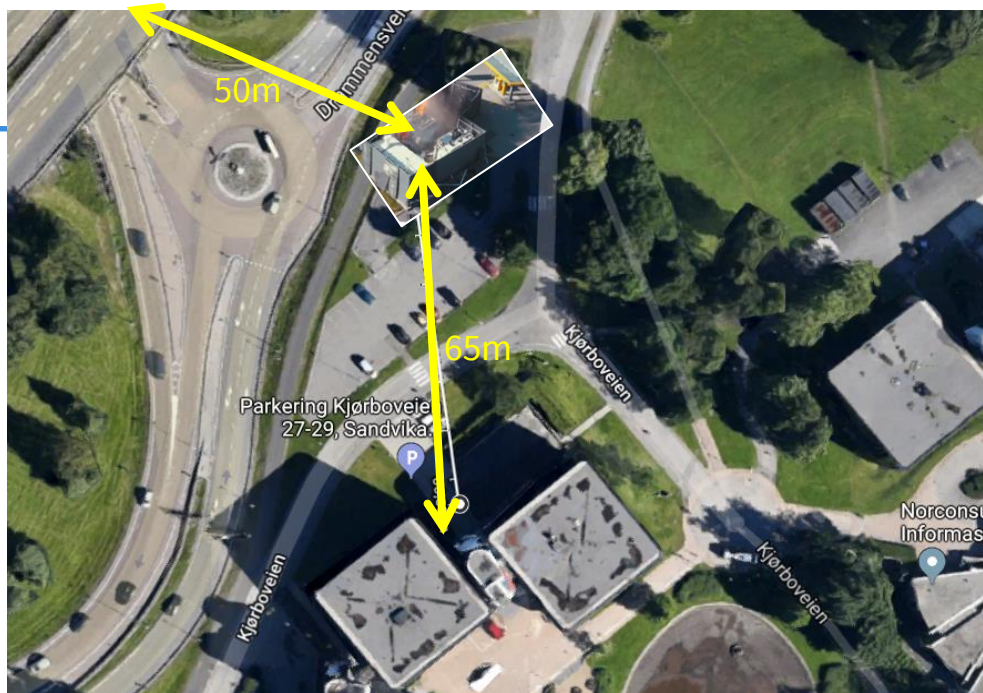
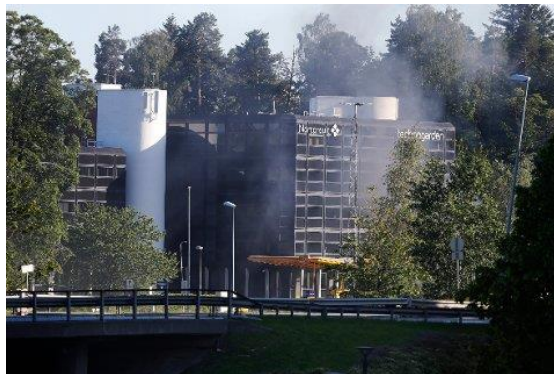
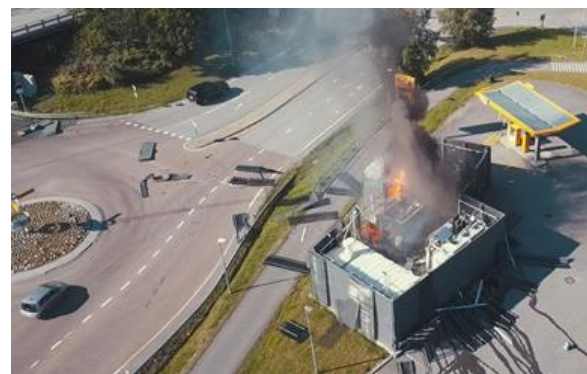
- Road and roundabout ~ 10m away
- Main highway (E18) 50m away (elevated)
- Office buildings ~65m away

The fence around the hydrogen units generally fulfilled its mission and protected the near surroundings from flames and direct explosion effects.

A limited part of the fence towards the roundabout however failed, generating potentially dangerous projectiles.

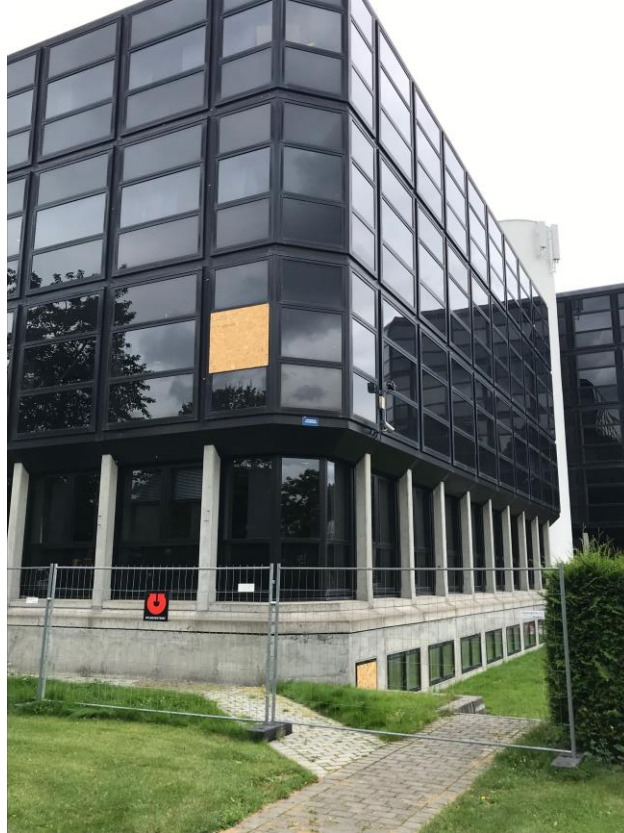
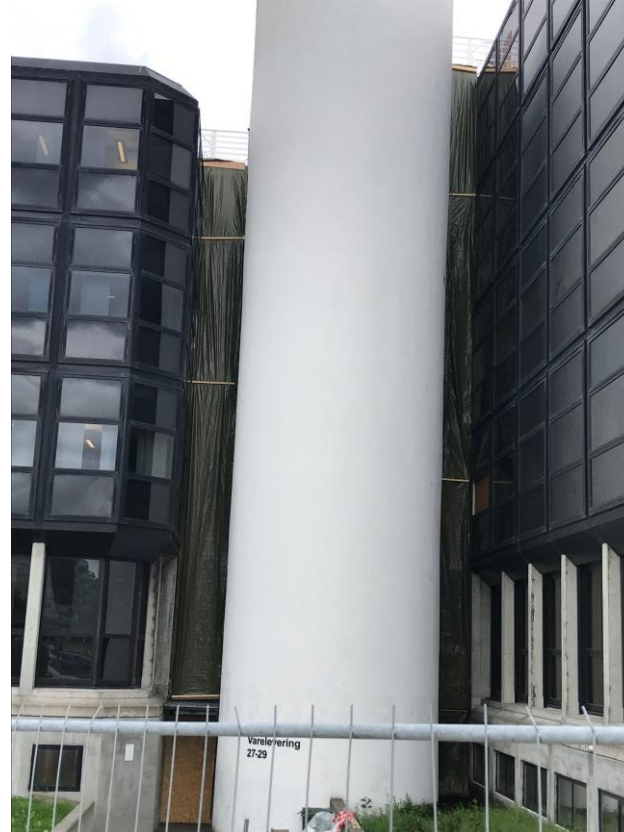
Visible building damage (6 weeks after explosion)

A few scattered windows, indication of more severe impact in corner

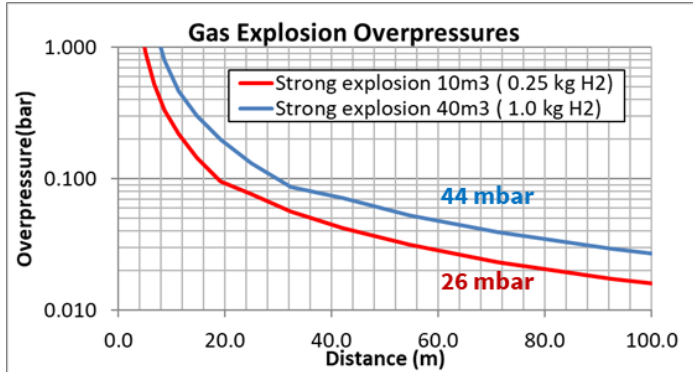
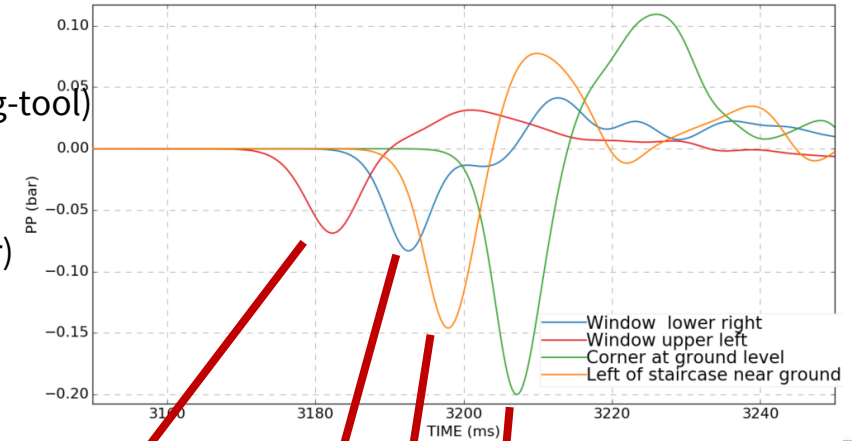
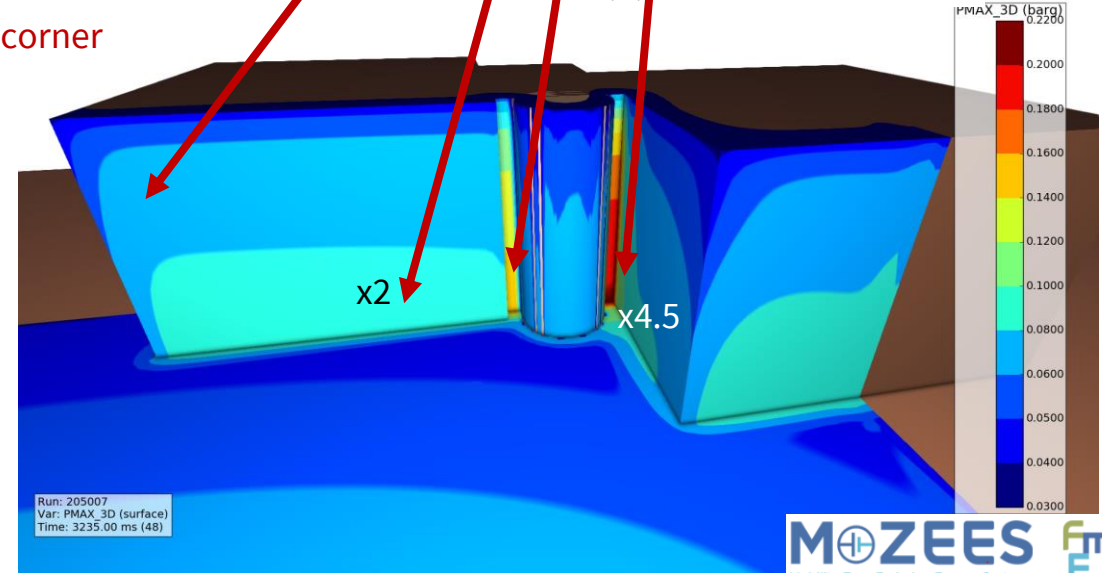
Blast onto building

- Side-on pressure ground ~45 mbar (consistent with LR screening-tool)
- Reflection x2 at front of building (90 mbar)
- Focused/reflected pressure 4-5 times higher in corner (200 mbar)

Due to shape of building, high pressures to be expected in corner

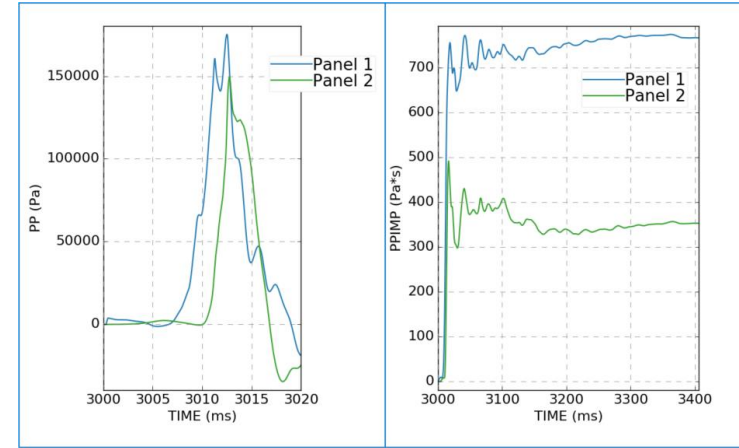
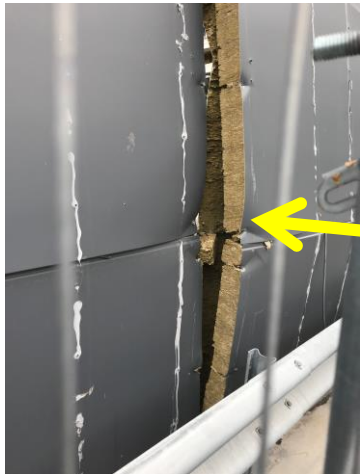
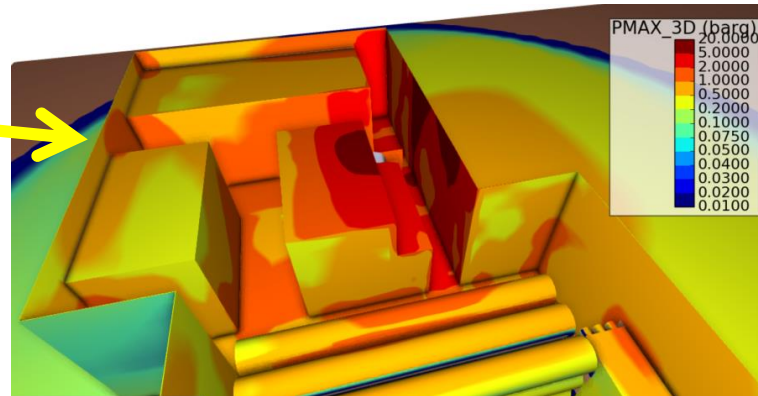
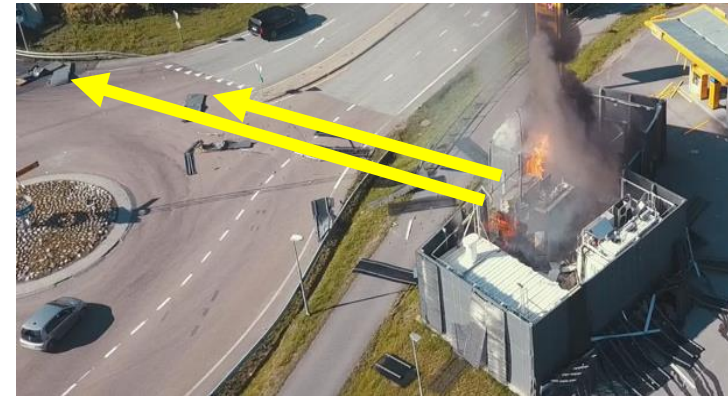
Wall projectiles

- Local pressure 10+ bar, average (2m x 3m panel) 1.5-1.8 bar
- Impulse 750 Pa s and 500 Pa s
- Weight of wall elements unknown
- 750 Pa s may throw 75 kg wall element (2m²) 41m

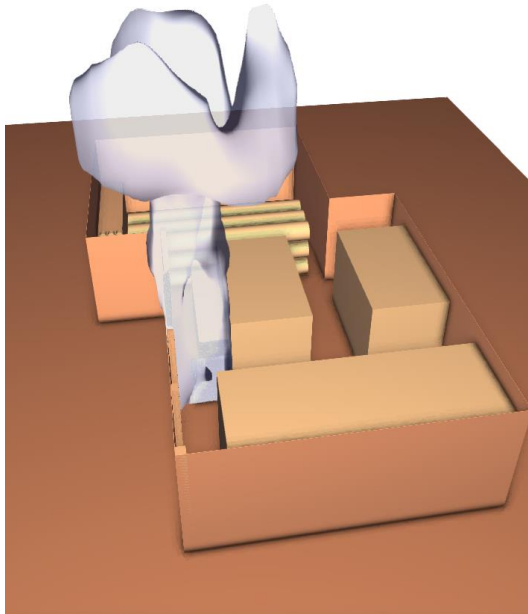
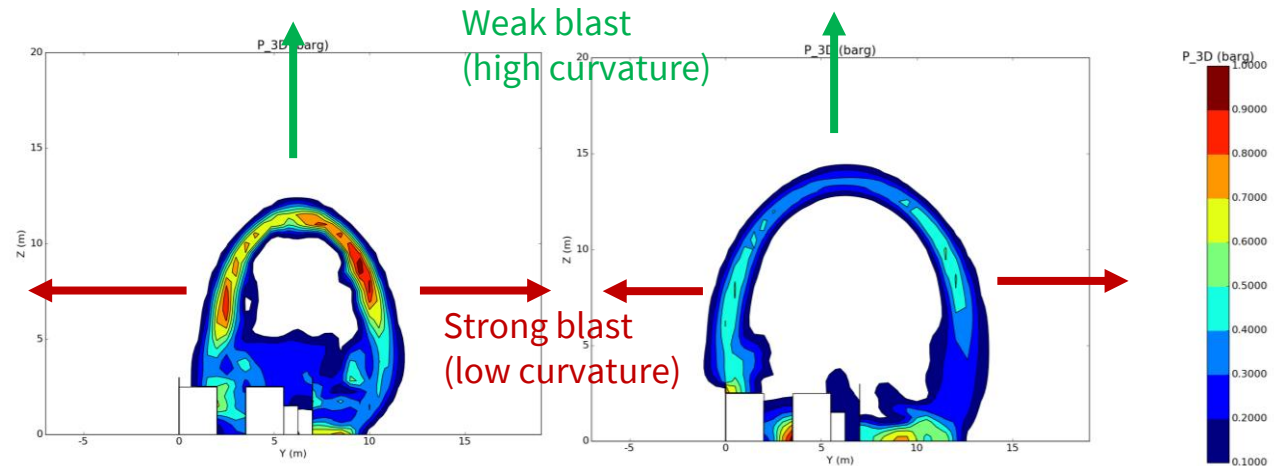
Blast exposure onto highway (E18)

Vertical elongated cloud may explain significant blast onto nearby elevated road

- Direct line of sight
- Shape of cloud would enhance horizontal blast strength

Prediction is supported by detonation experiments of elongated gas clouds giving double blast pressures across axis vs along

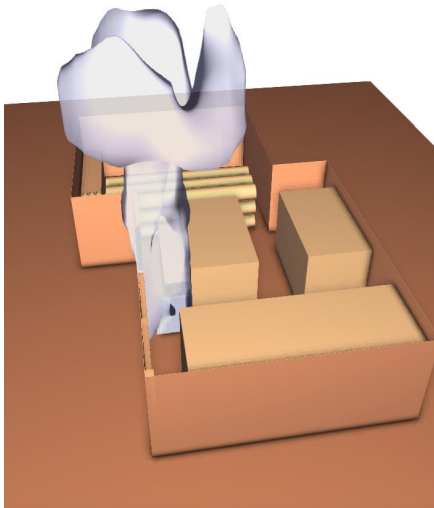
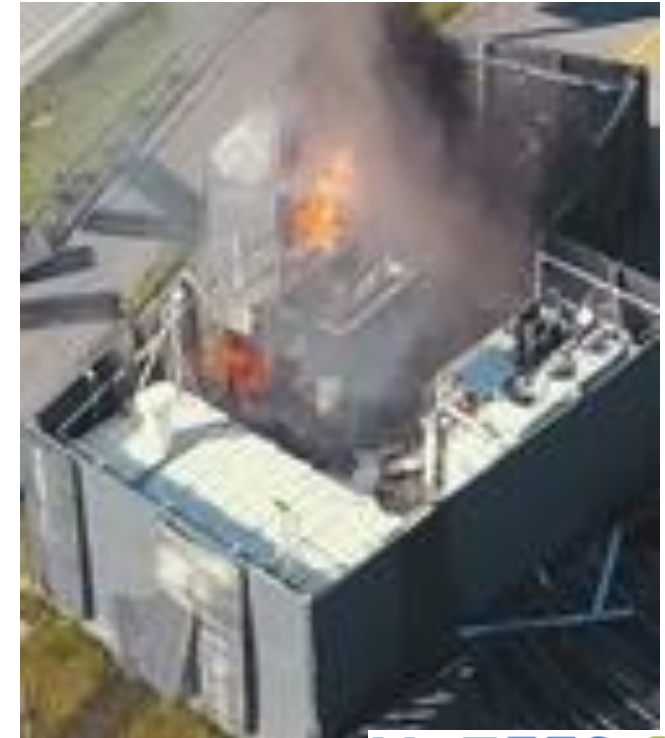
Second explosion in compressor module?

Gexcon mentioned “possible local DDT inside compressor module” & witness reported 1 strong +3 weak explosions

- Very strong outdoor explosion may have shaken compressor module and led to leak inside (?)
- With leak inside, and fires outside, ignition and explosion no surprise
- Pressure likely vented through doors and vent in roof
- Limited cloud volume (worst-case $\sim 10\text{m}^3$), fences would mitigate blast outside
- I doubt this scenario can explain failing fence or strong blast onto road/offices
