MoZEES Workshop

Hydrogen Safety: Kjørbo-incident, overview and perspectives

Olav Roald Hansen

CIENS, Oslo, October 23, 2019

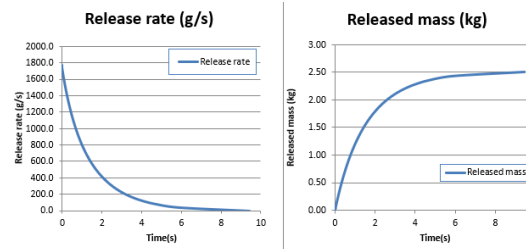
Release profile 7mm hole (38.5mm²)

- 1650 g/s to 237 g/s in 3s
- 2.0 kg released

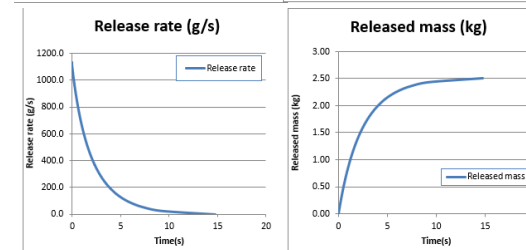
Release profile 5.5mm hole (23.7mm²)

- 1000 g/s to 285 g/s in 3s
- 1.7 kg released

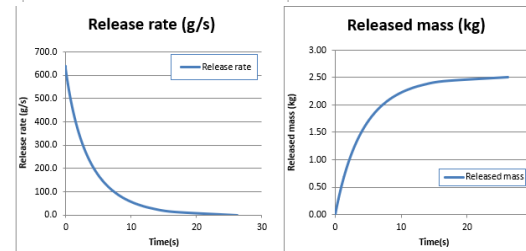
Release profile 4.4mm hole (15.2mm²)

- 640 g/s to 275 g/s in 3s
- 1.3 kg released

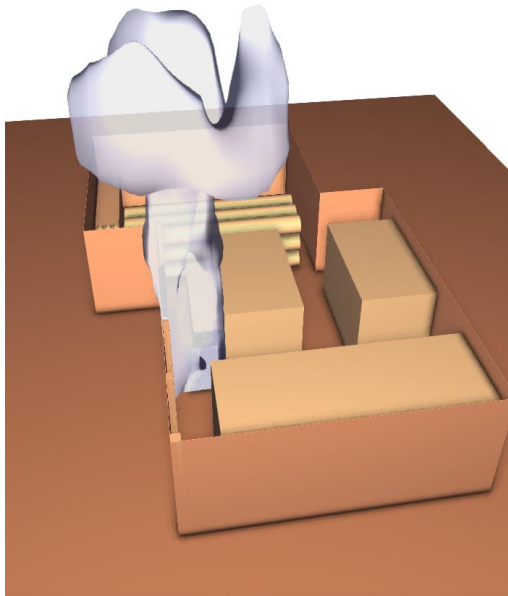
Maximum explosion energy (Q8) from 25m^3 to 34m^3 (0.63-0.85 kg hydrogen) at 3s

Equivalent stoichiometric cloud (Q9) was predicted to $13\text{-}18\text{m}^3$ (0.33-0.45 kg hydrogen)

640 g/s initial rate used
(worst case at 3s)
Reactive plume
15-60% shown

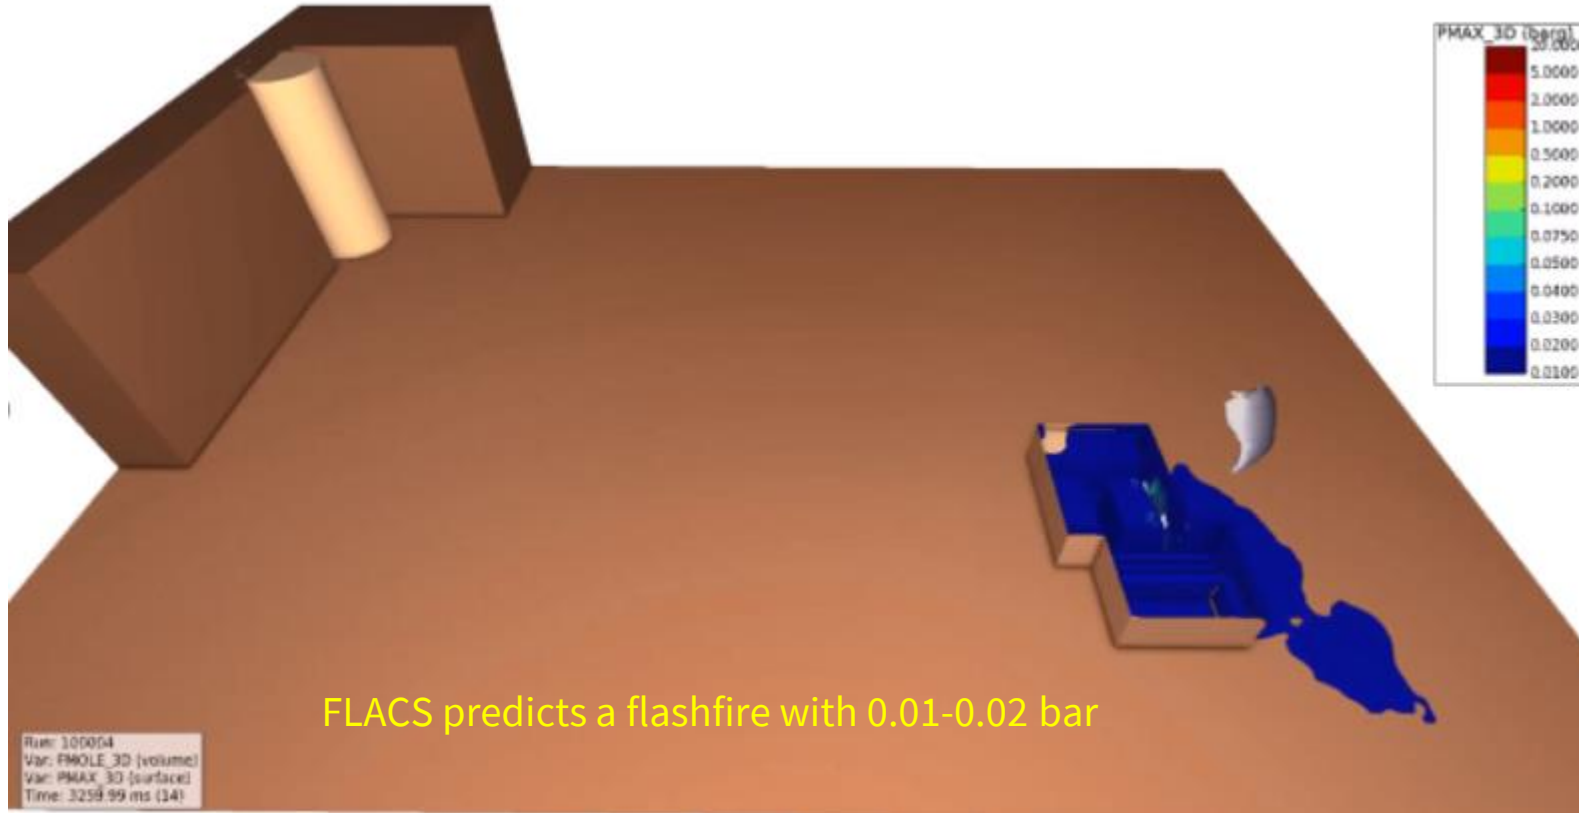
640 g/s initial release rate exploded (most reactive gas cloud at 3s, 0.45-0.85 kg hydrogen)

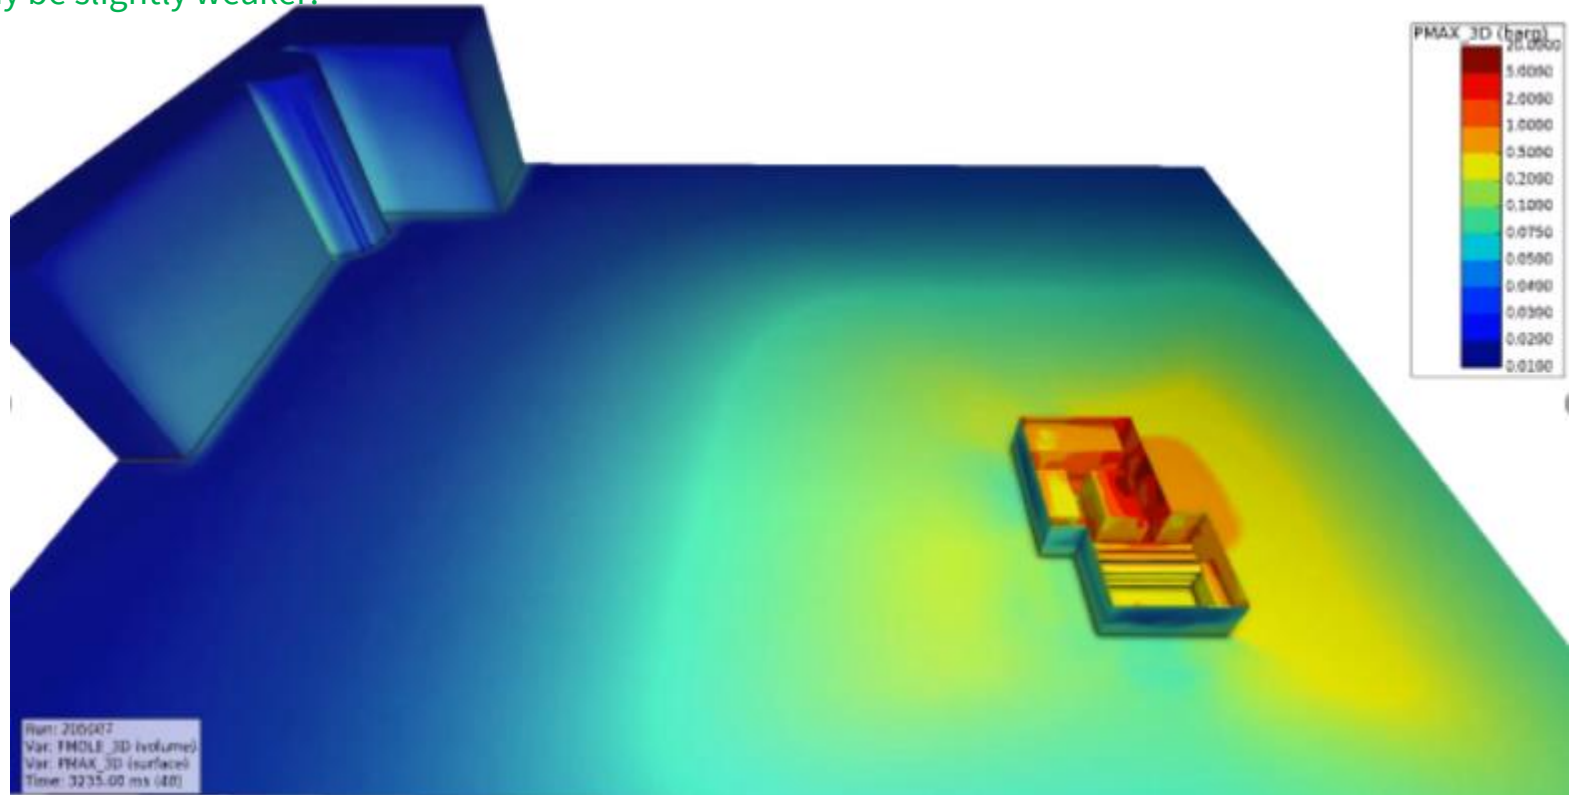
640 g/s initial release rate exploded (most reactive gas cloud at 3s, 0.45-0.85 kg hydrogen)

PS! Simulation is based inaccurate description of event and on worst-case dispersion scenario evaluated.
Actual blast waves may be slightly weaker.

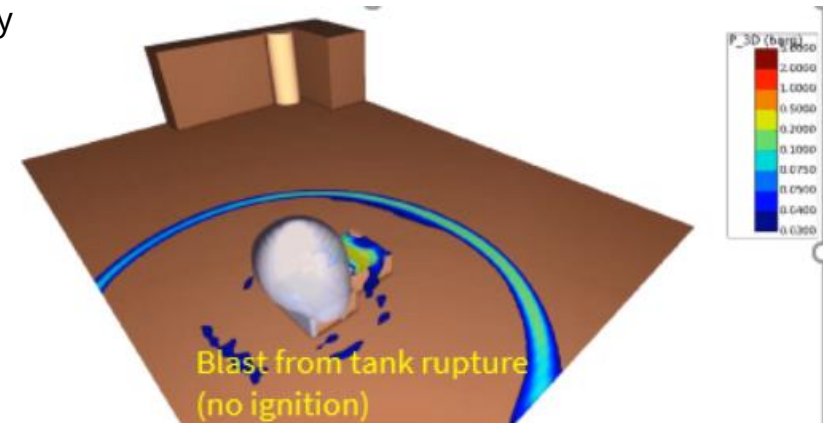
Vessel burst	Distance to pressure level			Pressure level			Distance	
Safety distances and loads	1 barg			0.2 barg			0.05 barg	
Distance	10.68	m		26.65	m		61.66	m
Pressure impulse	270.2	Pa s		120.2	Pa s		56.25	Pa s
Pressure duration	5.80	ms		12.91	ms		23.21	ms
				0.1 bar			65	m
							0.045	barg
							54.0	Pa s
							24.20	ms

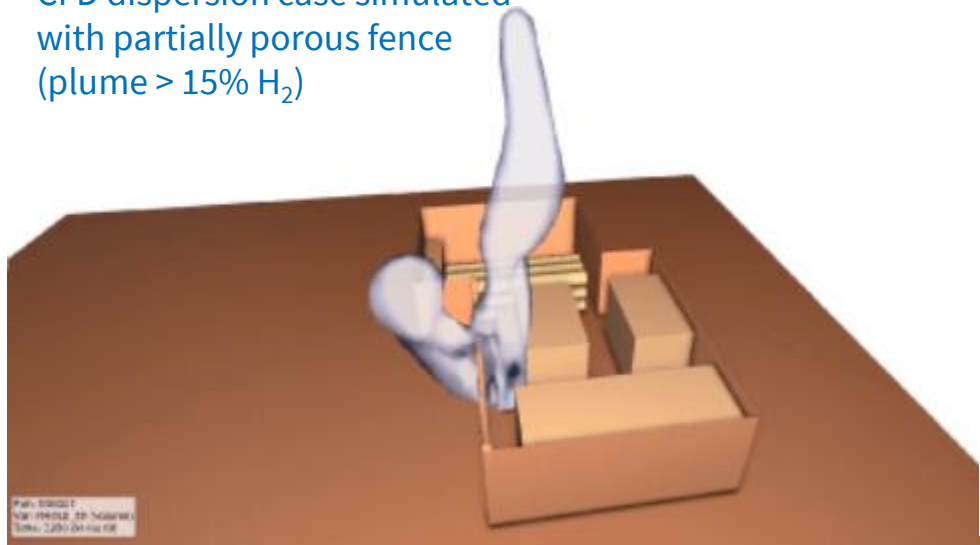
CFD dispersion case simulated
with partially porous fence
(plume > 15% H₂)

People outside porous fence would be exposed to
flames and pressures more than twice as high

- ⇒ Increased ventilation is an important measure for very confined modules where small releases of hydrogen can accumulate.
- ⇒ For a site like Kjørbo it is however NOT advised to replace solid fences with porous walls. This would potentially expose people outside the site to flames, projectiles and pressures, and will have an insignificant effect on risk for hydrogen scenarios as large releases outdoor will within moments seek upwards due to buoyancy.

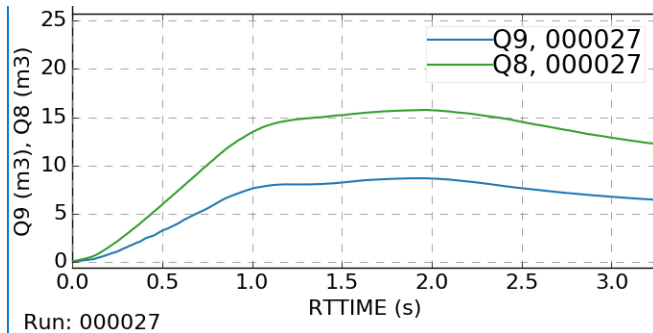
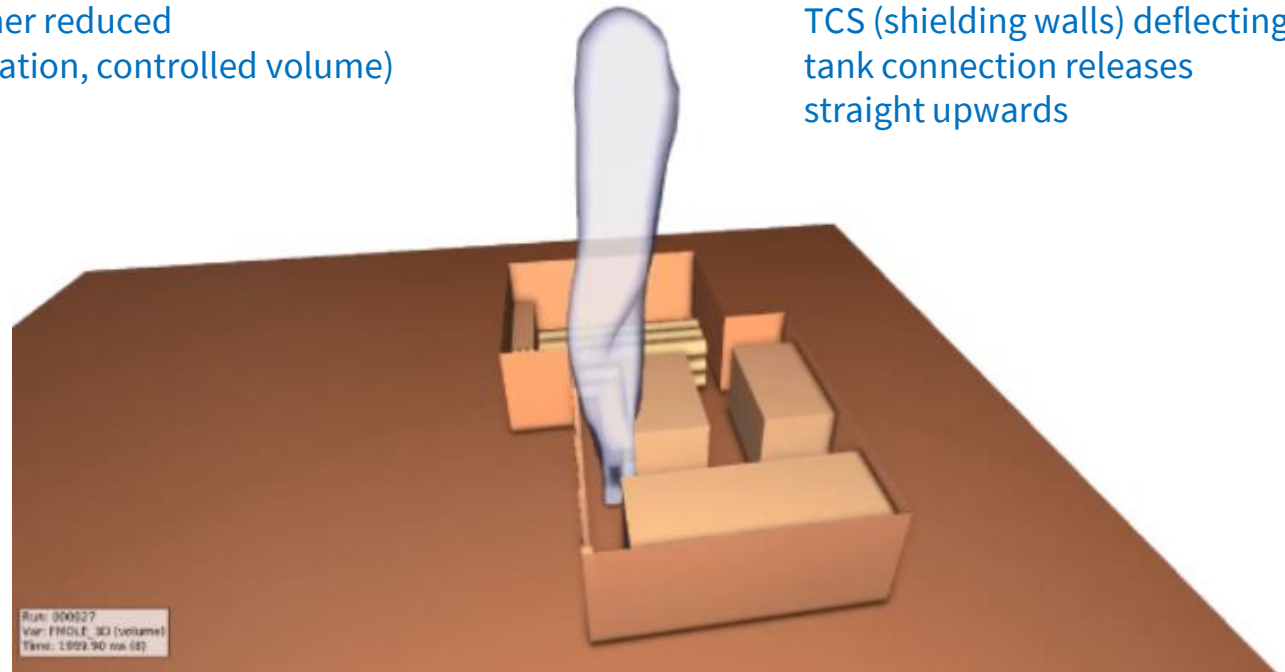
- Cloud sizes less than half, could be further reduced
- Ignition less likely in TCS (high concentration, controlled volume)
- Assumed very low likelihood for DDT

TCS (shielding walls) deflecting tank connection releases straight upwards

- One measure to consider, in particular on sites with limited space, is “tank connection space” (TCS) solutions leading leaked hydrogen safely upwards and away. TCS is required on gas-fuelled ships.
